Hunters Point Naval Shipyard BCT Meeting

Presentation Overview

Hunters Point Naval Shipyard BCT Meeting - April 25, 2013

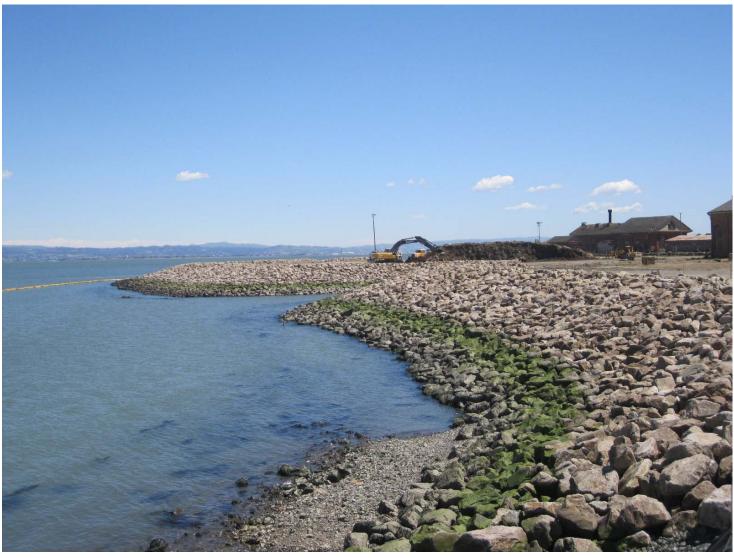
RA Photos Completed Revetment Structure

- Imported 12,000 tons of rip rap (by barge) and 5,200 tons of filter rock by truck for revetment construction (100% of total)
 - Barging rip rap saved 1,067 truck trips through the community
- Constructed ~1,600 of 1,830 LF of revetment (87% of total)
- 230 feet of revetment remaining to be constructed within Combined Sites Area

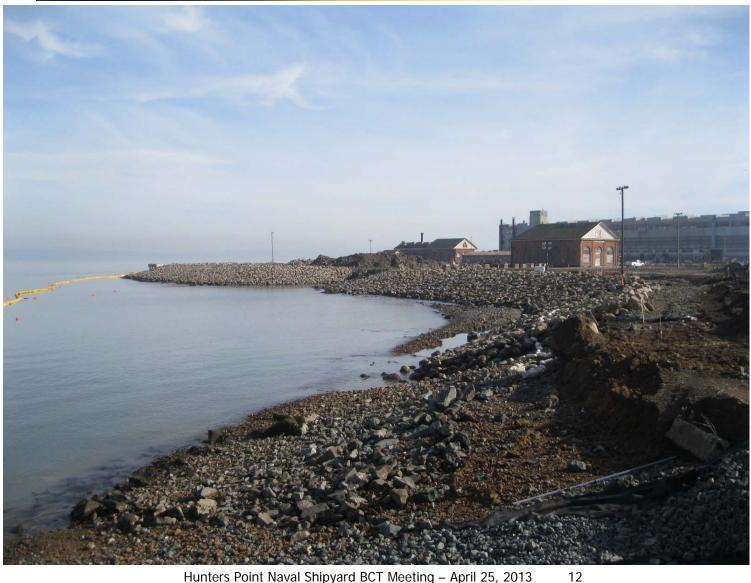
RA Photos IR-26 Revetment Completed to TPH AOC

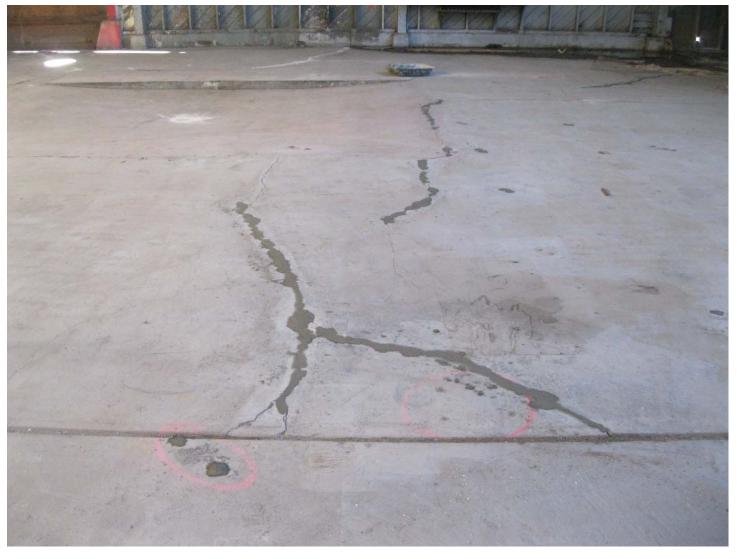
RA Photos Repaired Cracks/Holes in Building Foundation (Typ.)

- Inspected all building foundations to identify cracks, holes, trenches, and penetrations
- Completed building foundations repairs, including:
 - Grouting penetrations
 - Filling cracks and holes with mortar or concrete
 - Excavating top 6" of soil in trenches and backfilling with 4" AB and 2" AC
- Remaining work includes covering crawl space openings with wire mesh

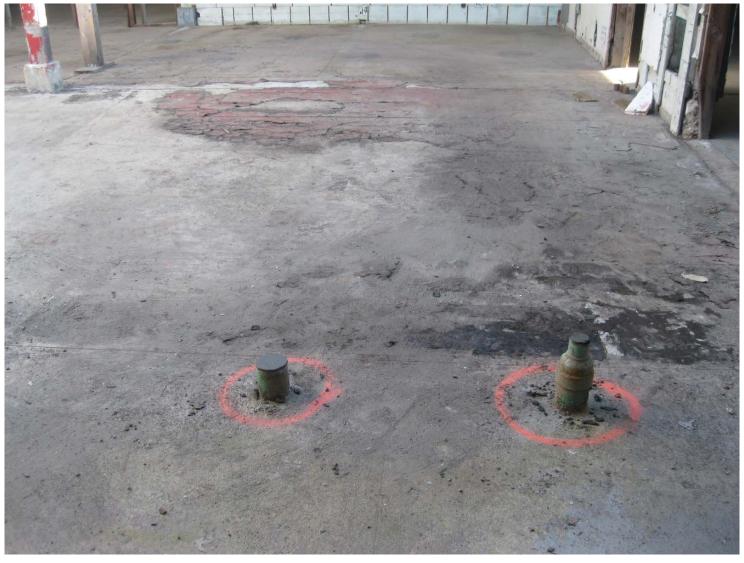
RA Photos Grouted Penetrations in Building Foundation (Typ.)

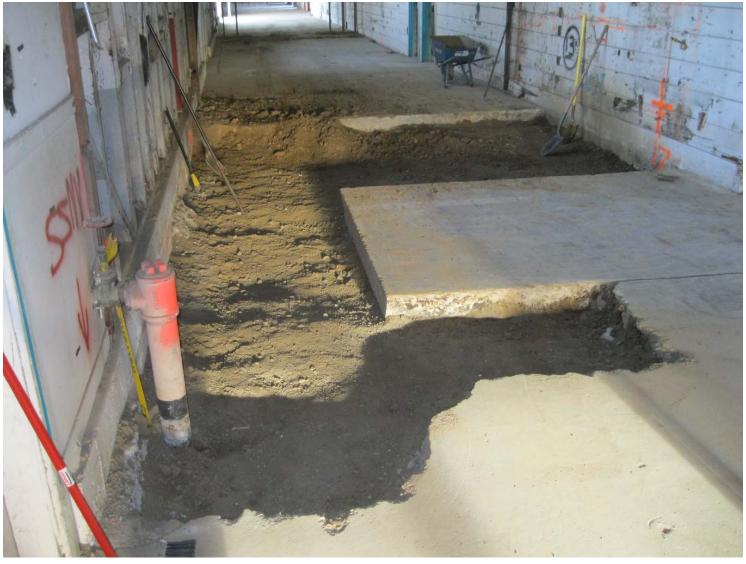
RA Photos Excavation of Soil in Building Trench (6-inch Depth, Typ.)

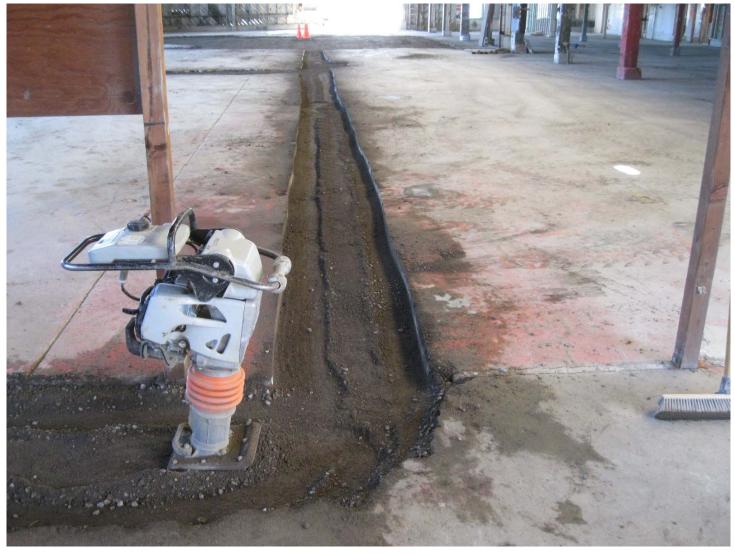
RA Photos Installation of 4 inches of AB in Building Trench (Typ.)

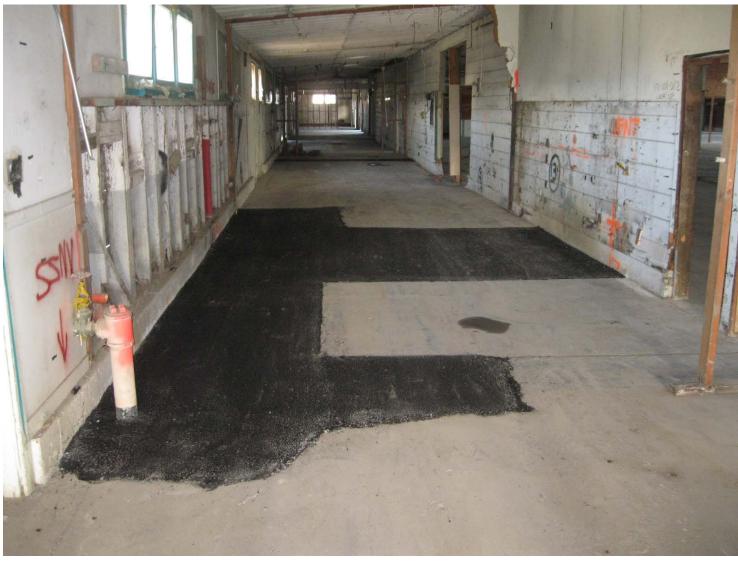
RA Photos Installation of 2 inches of AC in Building Trench (Typ.)
